# Manhole Inspection Summary

Manhole # S01AA2007MH

Insp Date: **8/3/06 8:23 AM**

**Location** Address: **6304 WIRT AVE**

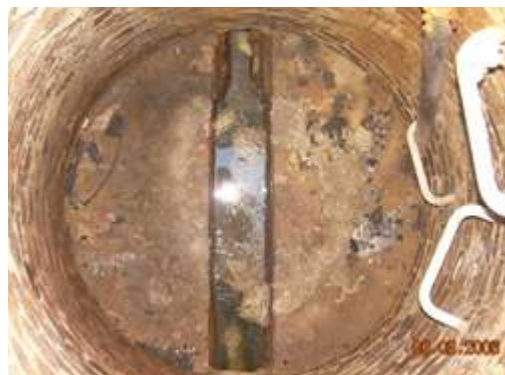
Top View

Adjustment, Corbel and Barrel infiltration.  
Evidence of surcharge - Bench debris.  
Channel debris.

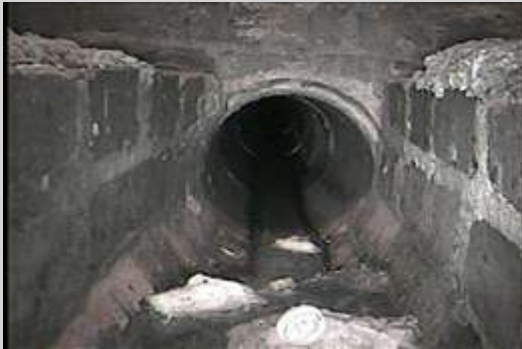
### 8 in. Circular Gravity Sewer Pipe Out @ 12 O'Clock

Deposits: ☐ None ☒ **Mud** ☐ Sludge ☒ **Debris** ☐ Grease

Silt Depth: **0** (in.) Deposits Extent: **Light**

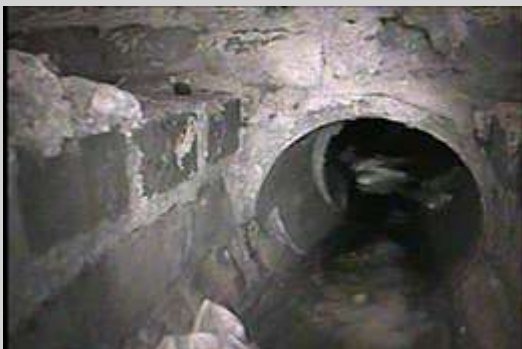
### 8 in. Circular Gravity Sewer Pipe In @ 6 O'Clock

Deposits: ☐ None ☒ **Mud** ☐ Sludge ☒ **Debris** ☐ Grease

Silt Depth: **0.5** (in.) Deposits Extent: **Light**
